Engineering Synopsis- 402 West Market – Diner

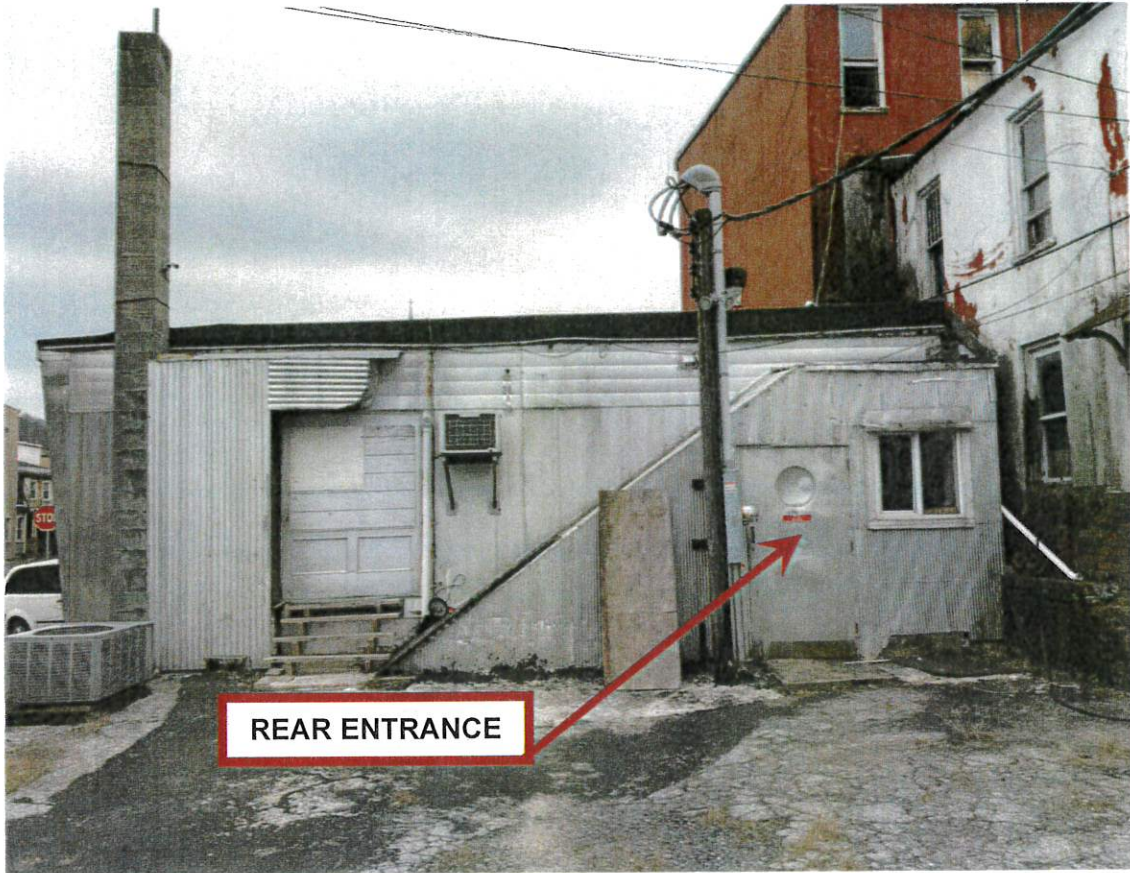
Rear view of 402 W. West Market Street Diner

The rear wall and emergency door need replacement.

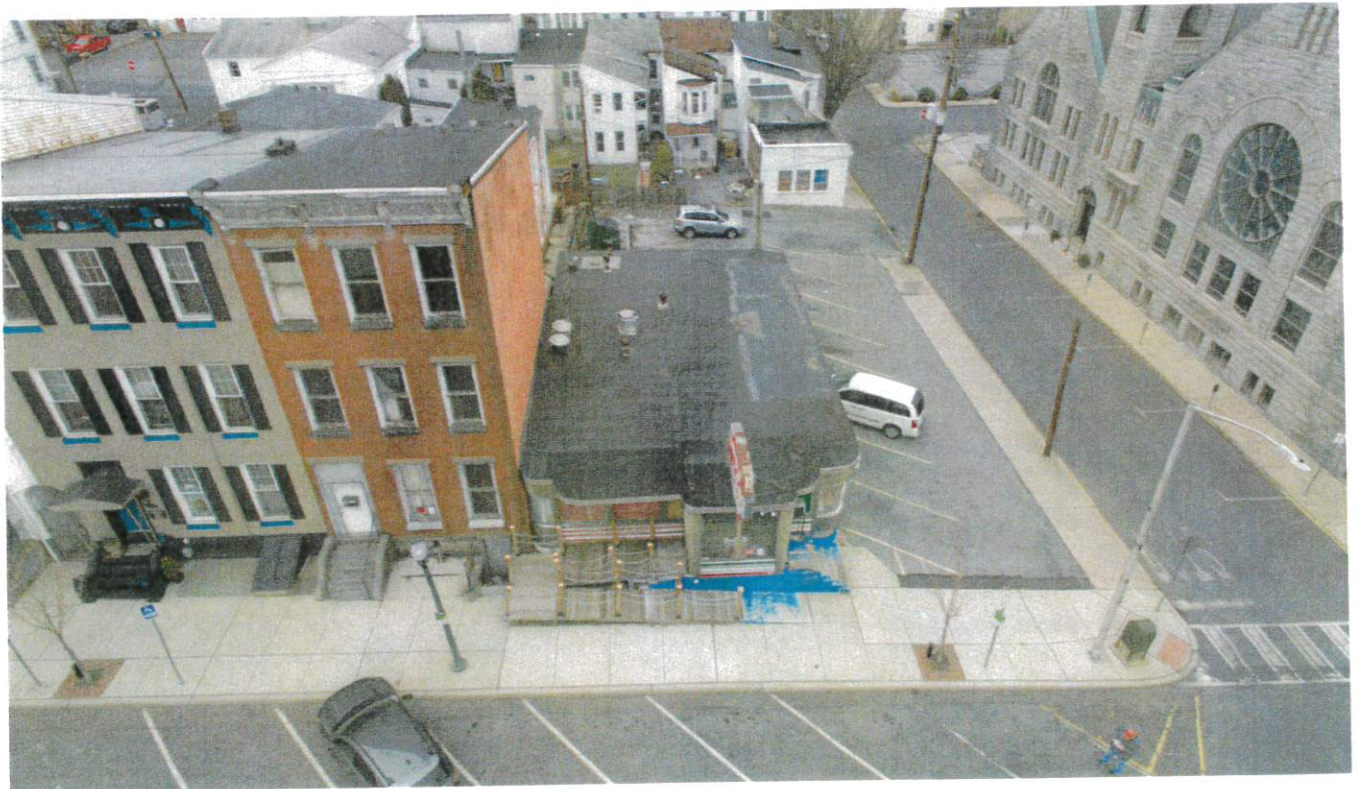
The steel roof underlayment is rusted and compromised. Replacement is required.

Aerial view of 402 W. West Market Street Diner showing the need for a complete roof repair since the underlayment is rotted.

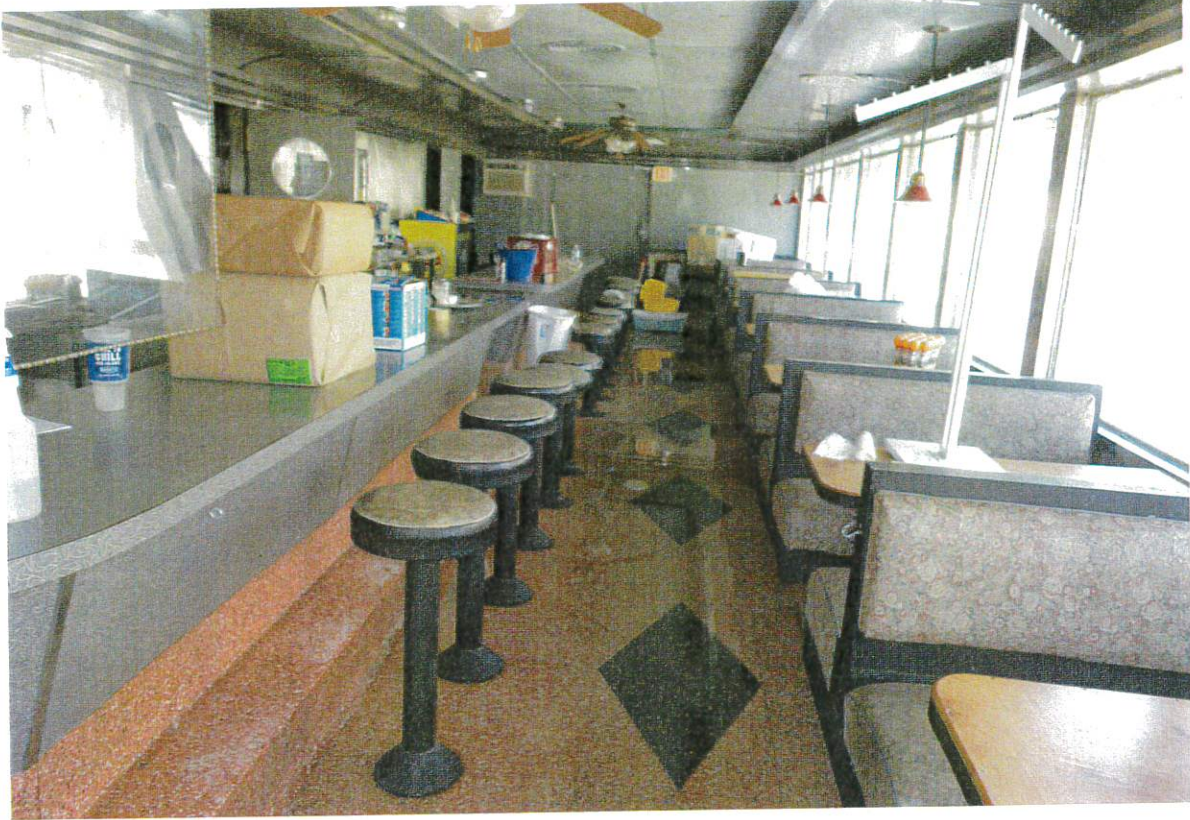
Water damage and general age and wear have contributed to the poor condition of the flooring. It needs to be replaced.

Inside the Diner @ 402 W. West Market Street Diner showing the wet floors

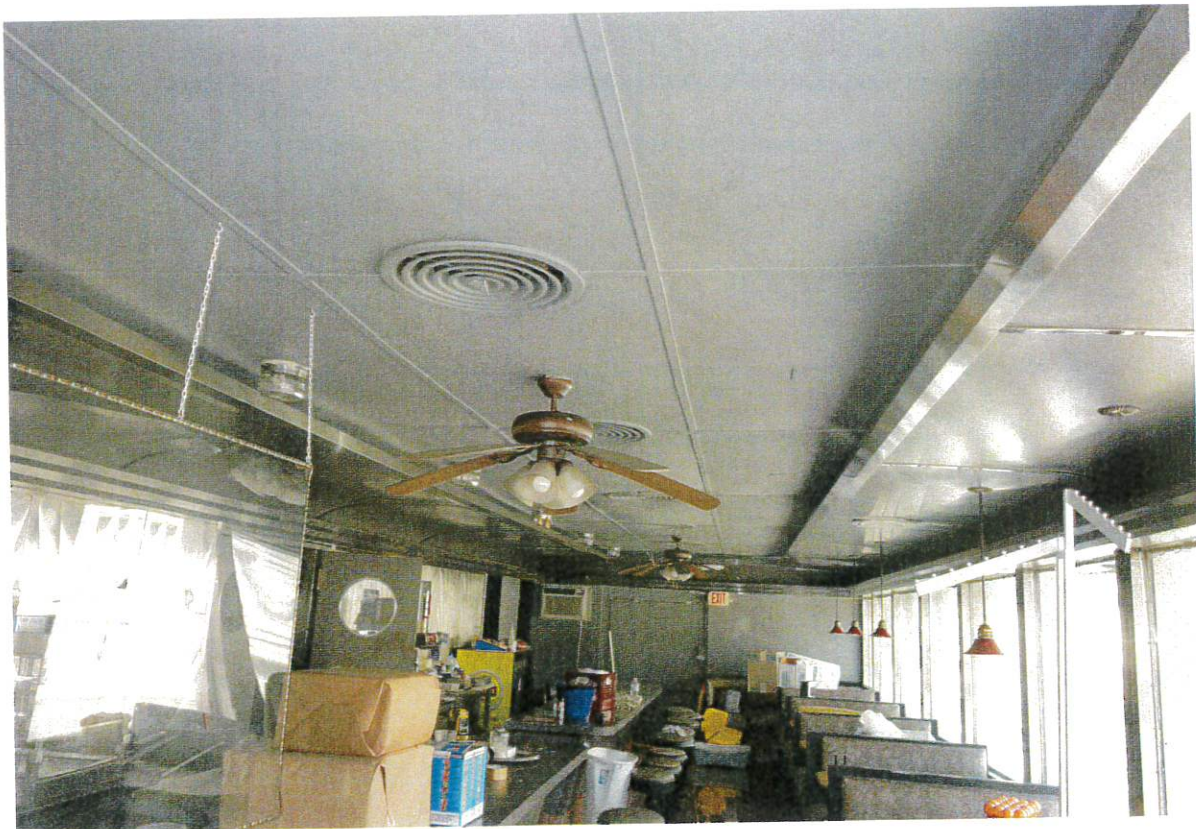
The roof is in poor condition, with multiple problems including leaks near roof fans, failed seams, and an aged rubber roof. Replacement is required.

Showing the leaks in the ceiling

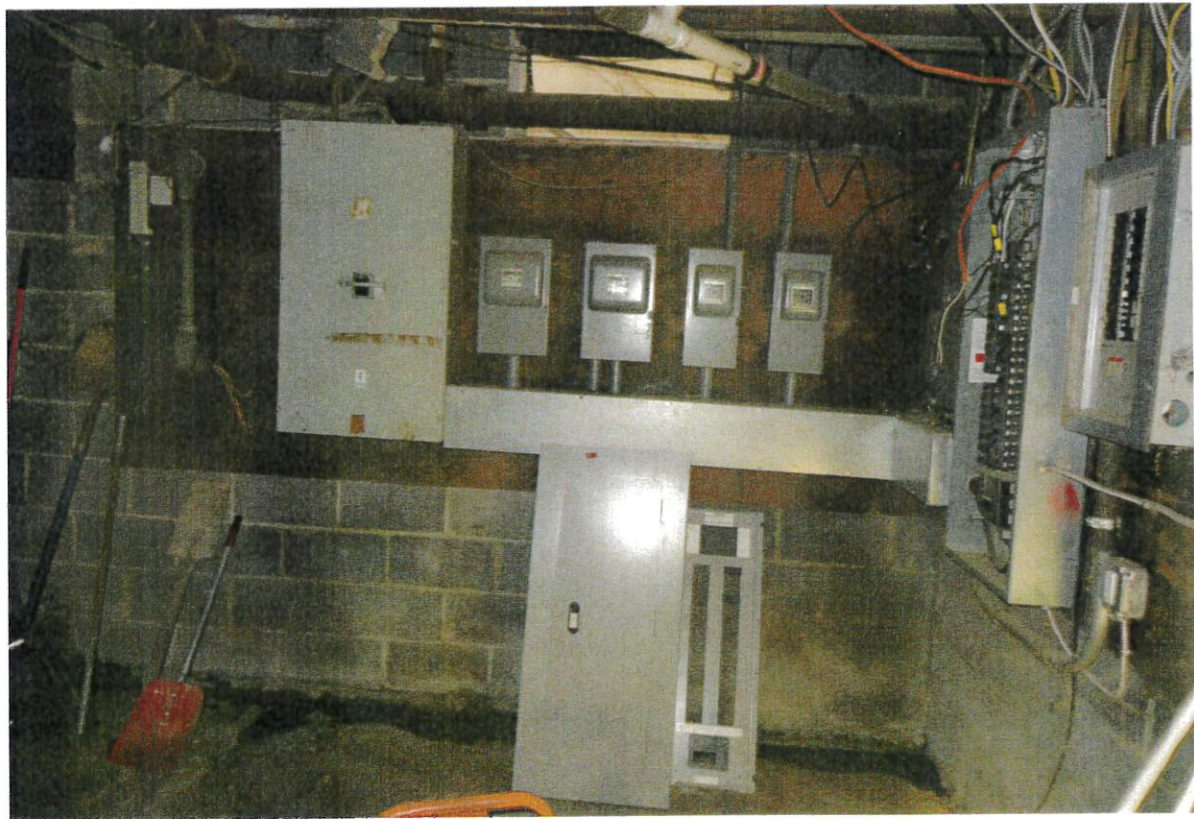
The entire electrical service is in poor condition. Functional electrical service, designed and built according to current codes and standards is needed.

The wiring must be totally changed to bring up to code.

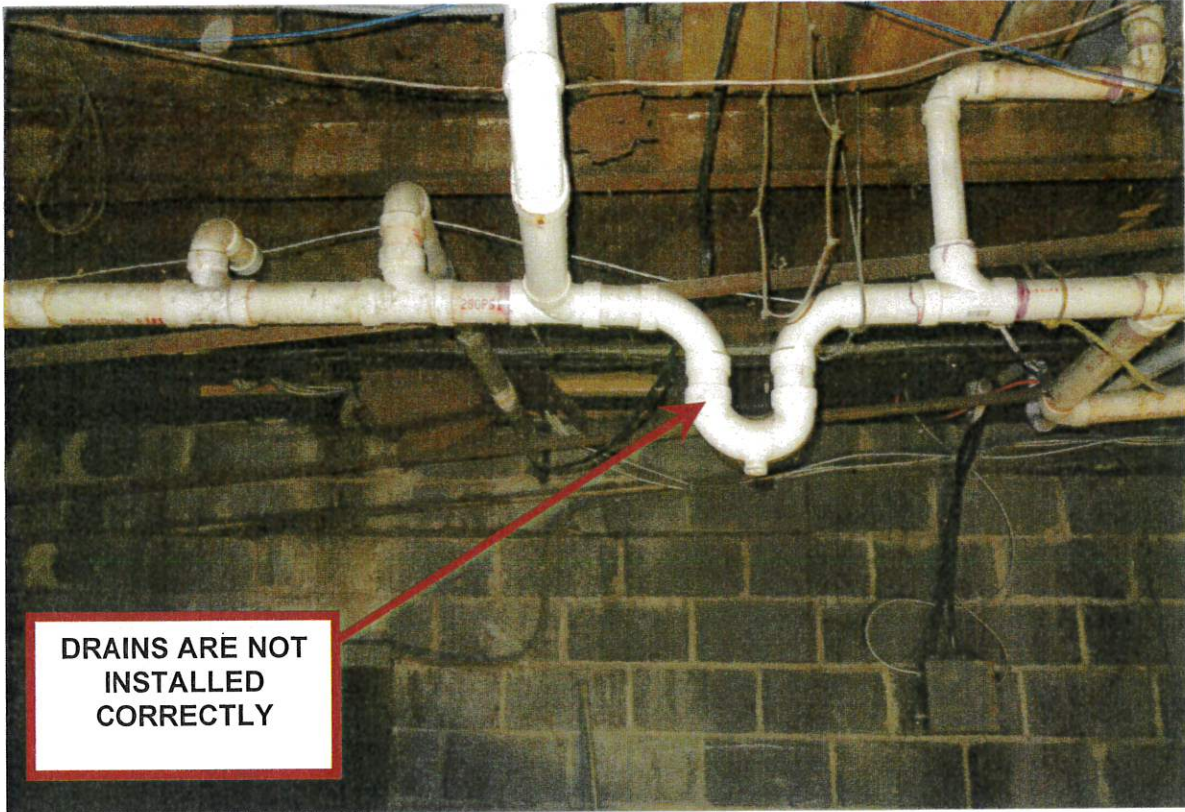
All Plumbing is in poor condition. Renovation and upgrades to the facility would require new plumbing, installed in a comprehensive manner.

The plumbing must be totally changed to bring up to code.

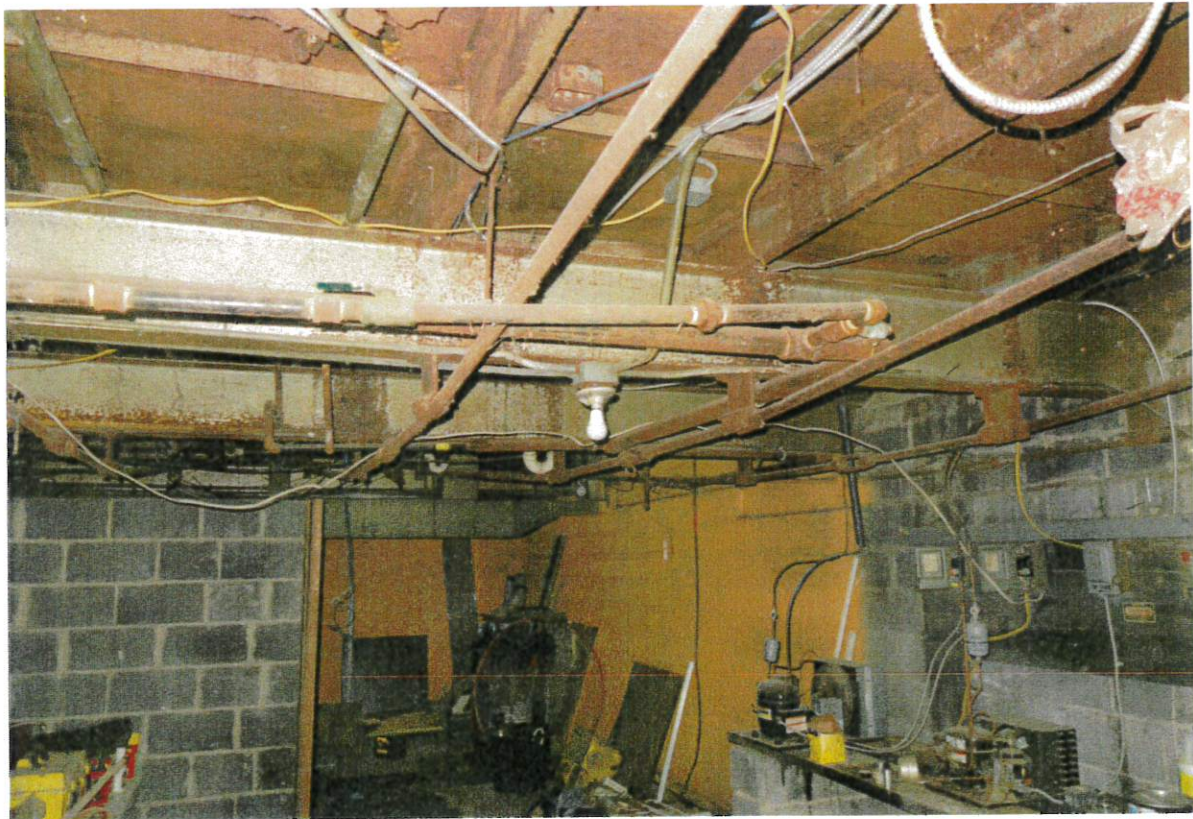
More rotting of the floor system.

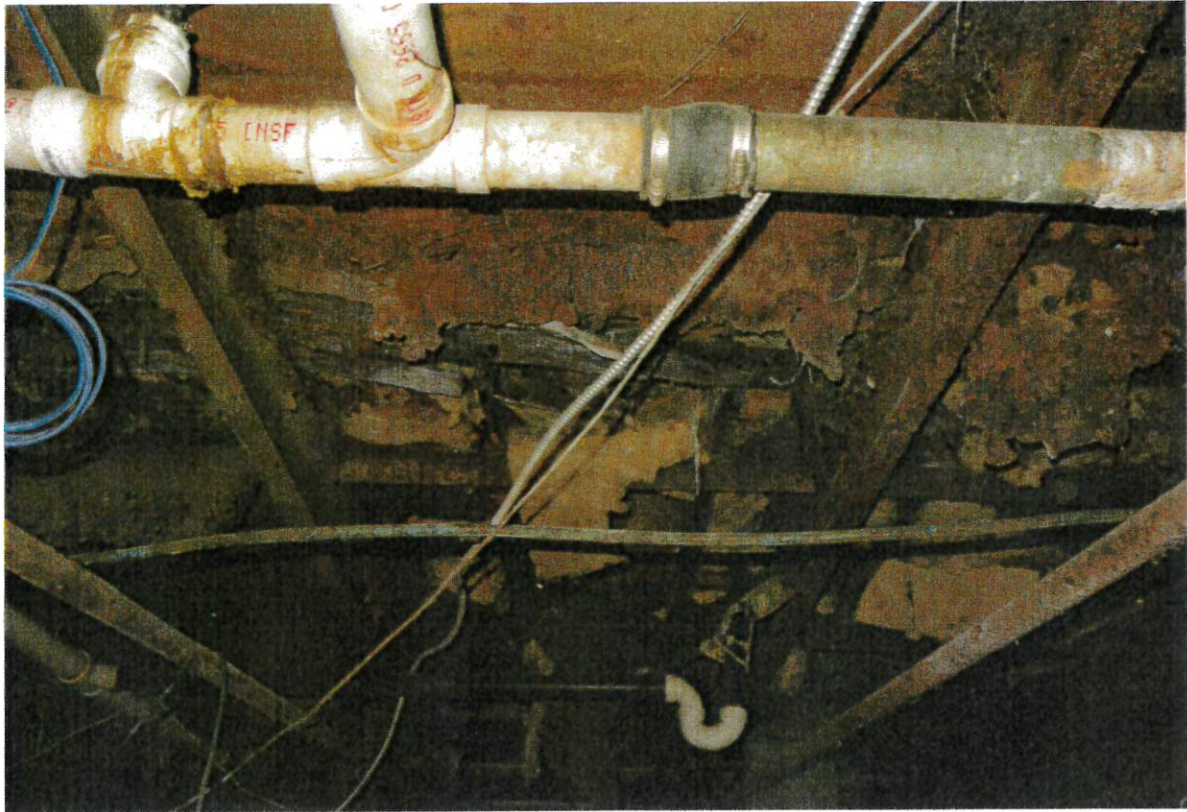
The floor support must be totally changed to bring up to code.

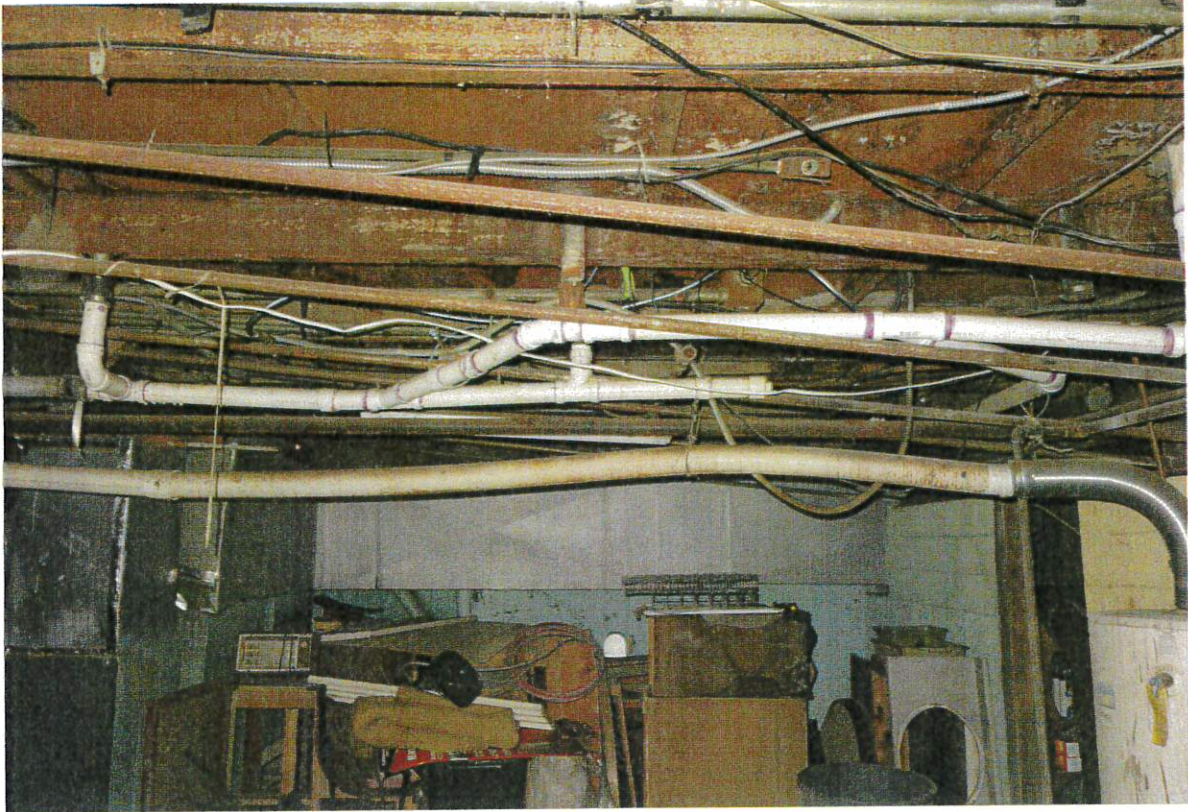
The plumbing must be totally changed to bring up to code.
