Engineering Synopsis- 404 - 406. W. Market -Apartment Bldg.

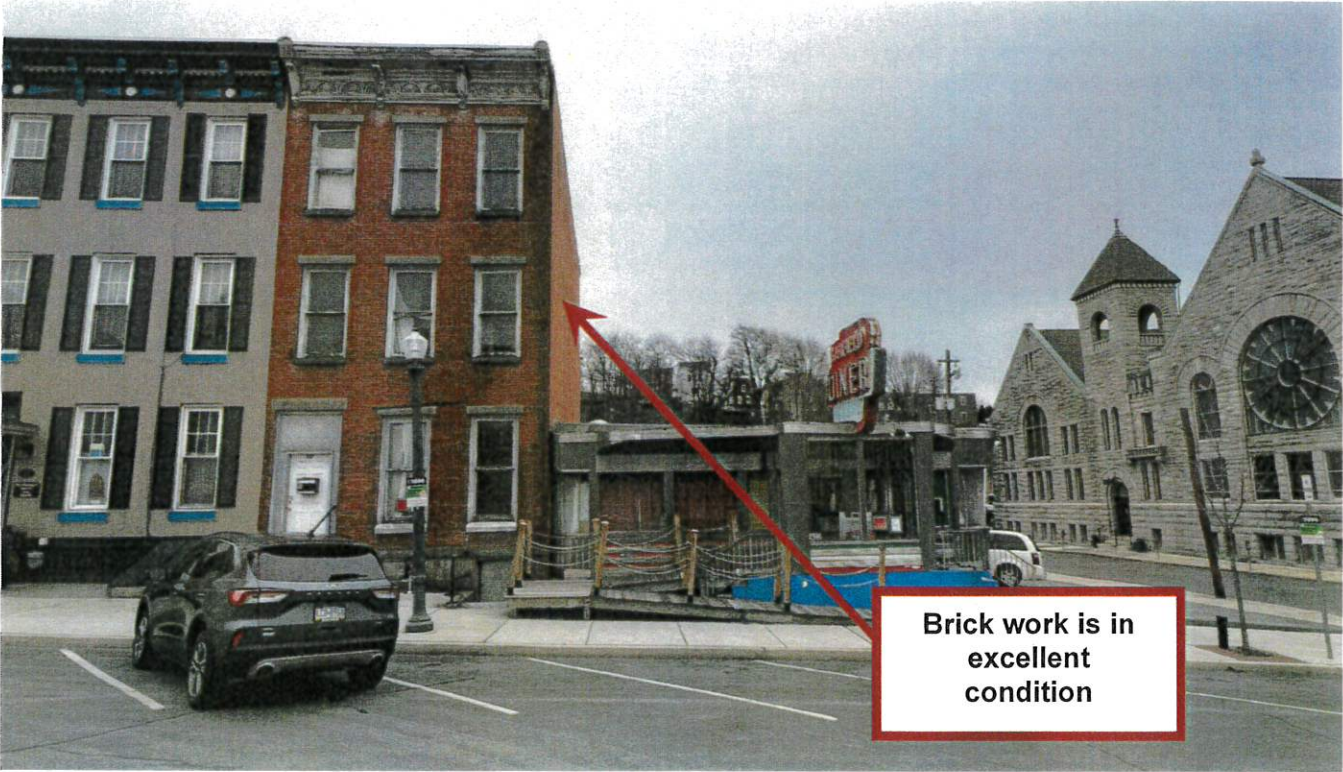
Side view

Brick work is in excellent condition

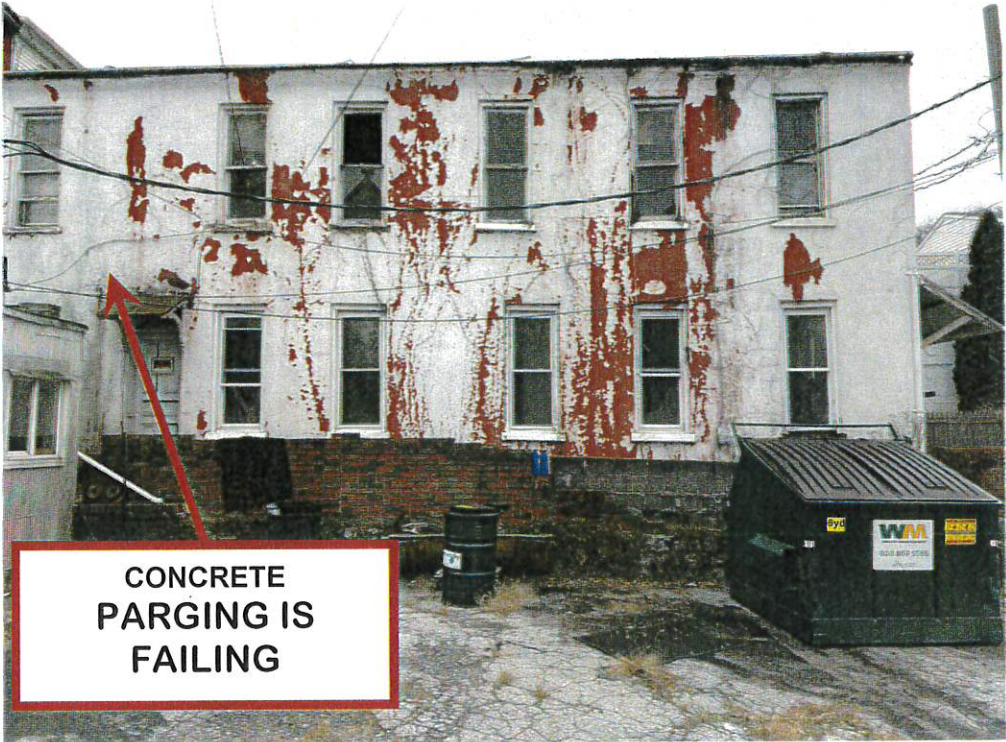
**CONCRETE
PARGING IS
FAILING**

Rear view side view
this area should be demolished

The repairs needed to restore this building are significant, however, the original portion of the building facing Market Street is structurally sound. The rear addition, would most likely require some level of demolition to address the safety and stability of the entire structure.

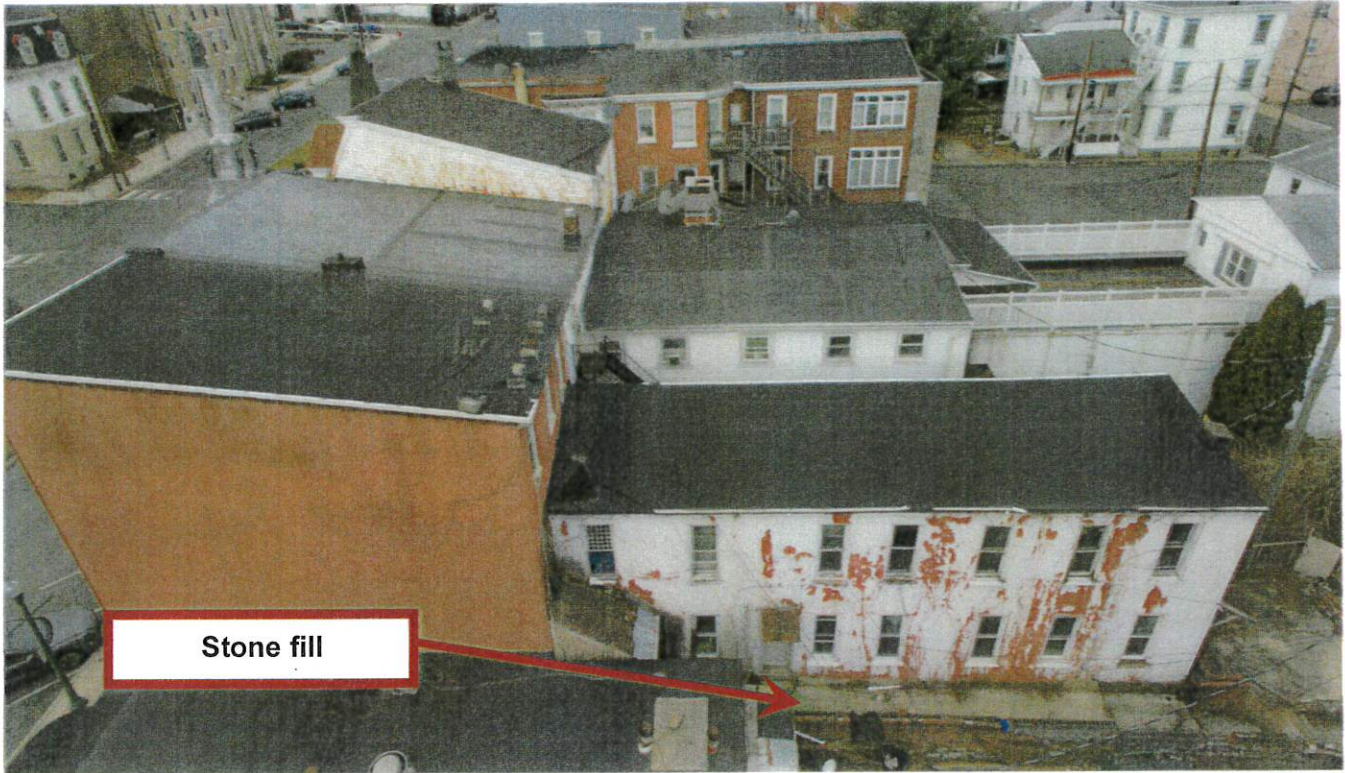
Arial view showing that the front is structurally sound but the rear should be demolished
